Smoke and Dye-Water Observation Summary

Western Run Pilot Project - Baltimore Maryland

INSPECTION REPORT

REMARK: DYE TEST 108 B 7

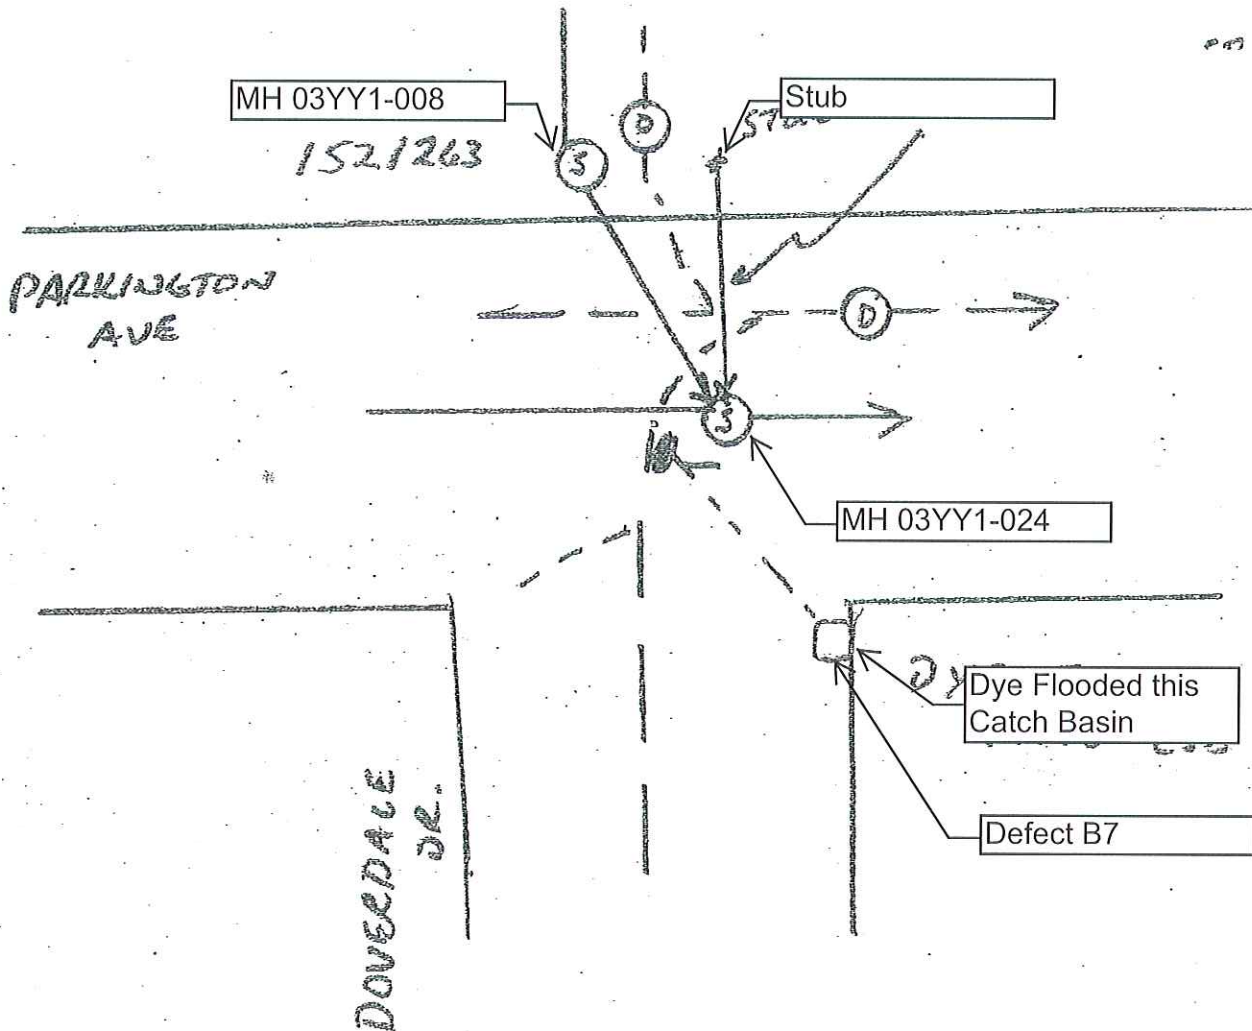
Dye Test 108

No Dye was seen in the Sanitary sewer.

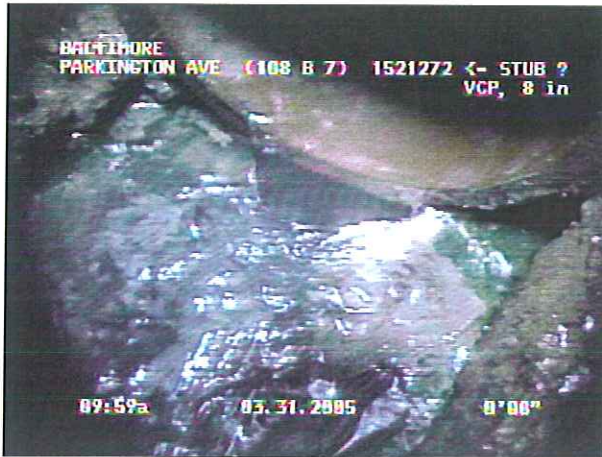
IMAGE: 36a, TAPE #: JAM 2, 00:46:32
0FT, separated joint medium, AS PIPE COMES INTO M.H.
1521272 FROM 1521273

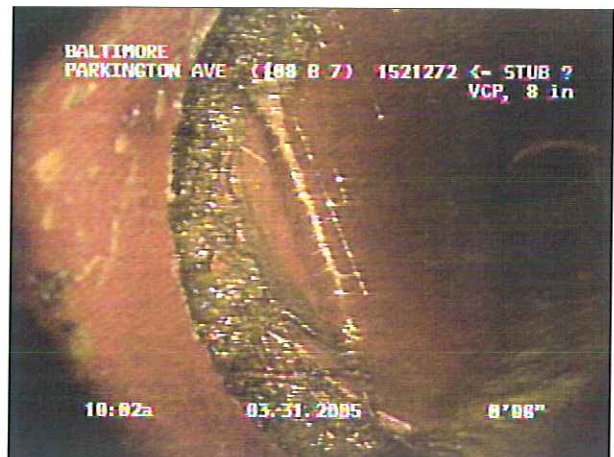
IMAGE: 37a, TAPE #: JAM 2, 00:47:39
7FT, roots medium, from 06 to 12 o'clock

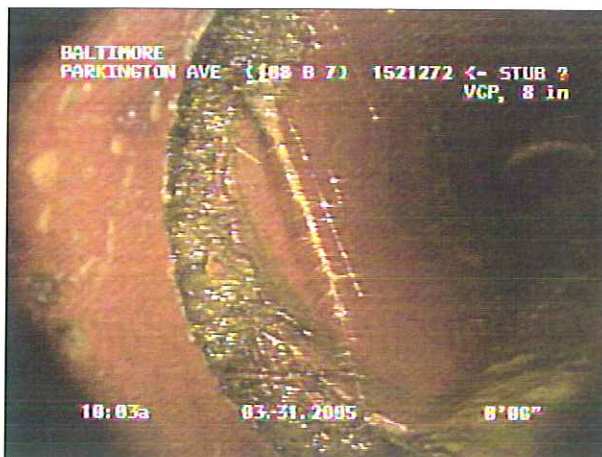
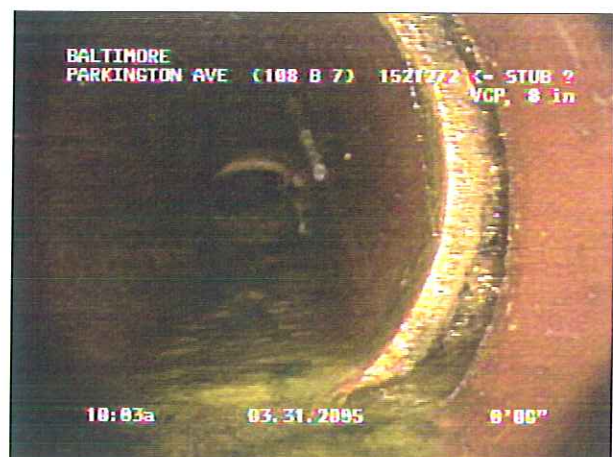
IMAGE: 38a, TAPE #: JAM 2, 00:47:39
7FT, Infiltration Running at joint at 04 o'clock to 12 o'clock

IMAGE: 38b, TAPE #: JAM 2, 00:47:39
7FT, Infiltration Running at joint at 04 o'clock to 12 o'clock

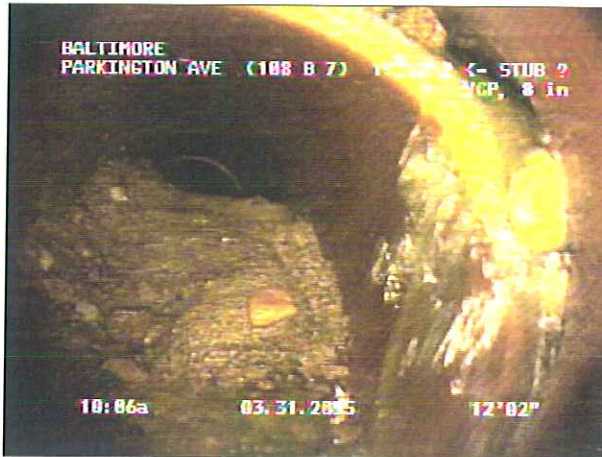
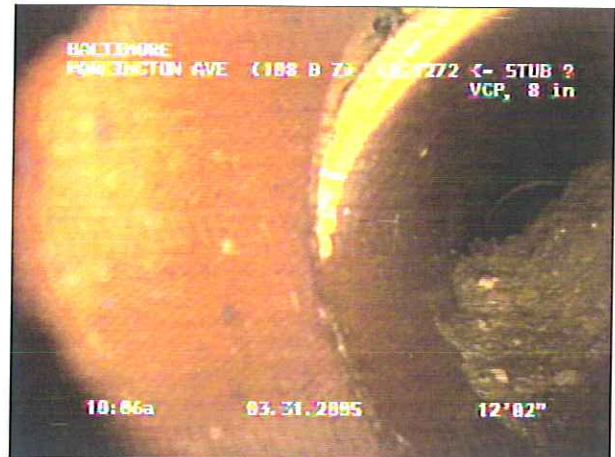
IMAGE: 39a, TAPE #: JAM 2, 00:48:50
12.17FT, offset joint, severe

IMAGE: 39b, TAPE #: JAM 2, 00:48:50
12.17FT, offset joint, severe

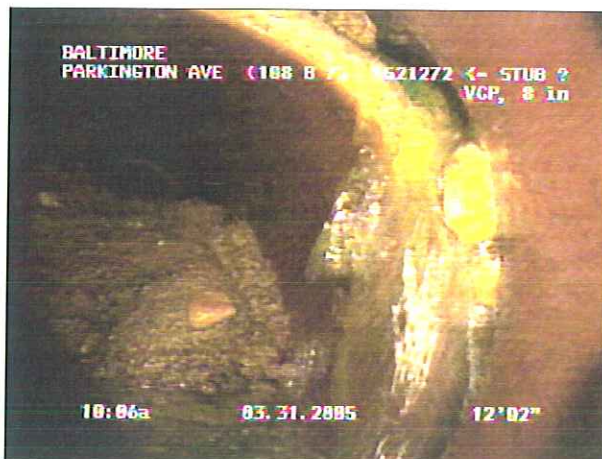
IMAGE: 40a, TAPE #: JAM 2, 00:49:21
12.17FT, Infiltration Gushing at joint at 02 o'clock
